Hanover County, Virginia - Shoreline Inventory Report: Methods and Guidelines

Hanover County, Virginia

Shoreline Inventory Report

Methods and Guidelines

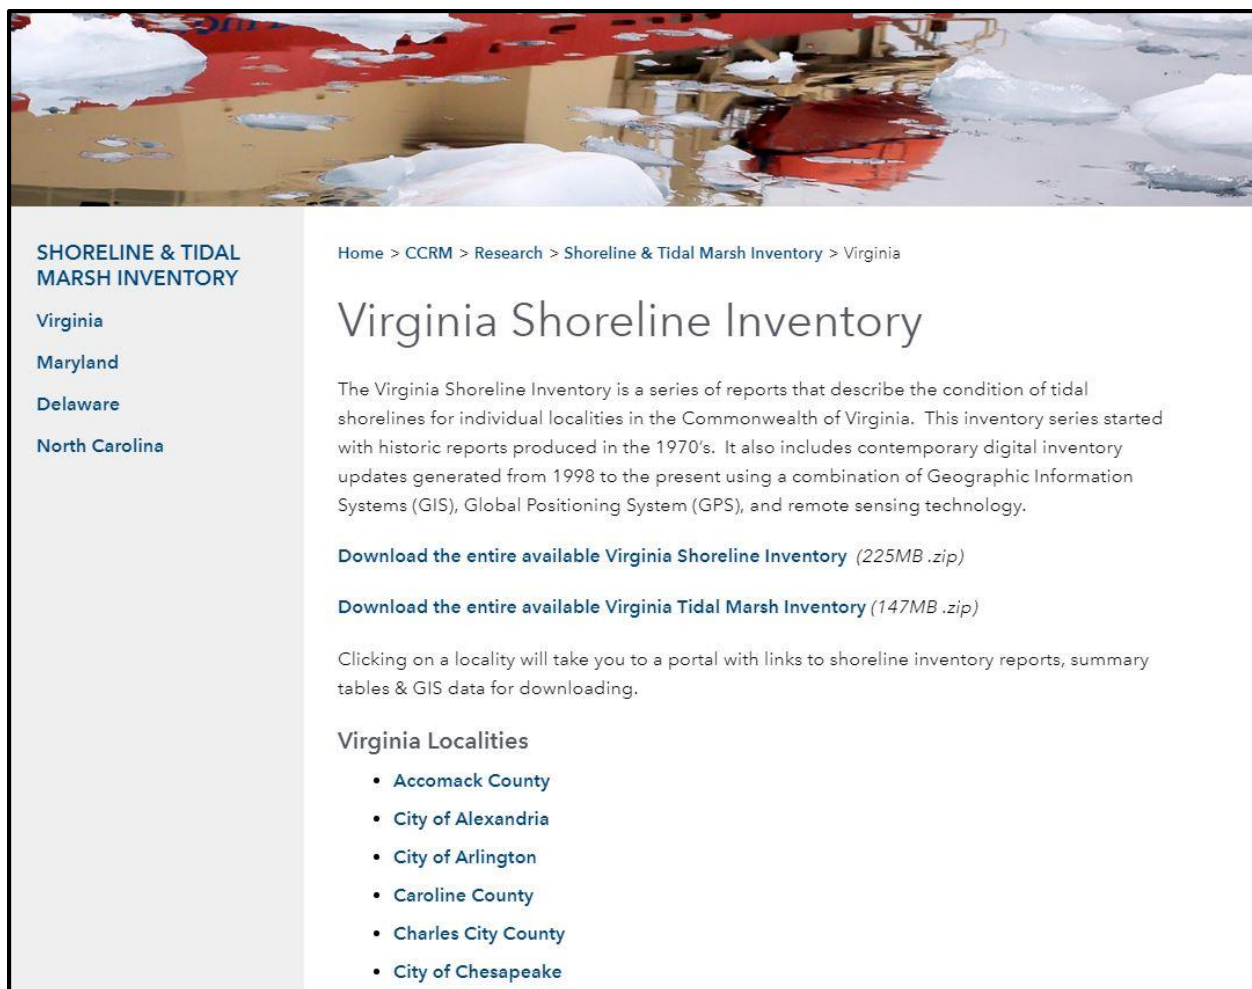
Figure 1. Shoreline Inventory Website

2.4c.) Map Viewer and Summary Tables: The Hanover County Shoreline Inventory is delivered to the end user through a website; <http://www.vims.edu/ccrm/research/inventory/virginia/index.php> (Figure 1.), by clicking on Hanover County in the list of localities. The new format for Shoreline Inventories includes a map viewing tool rather than maps in pdf format. The map viewer allows users to interact with the datasets within a familiar “google” type map service that was developed with Javascript. Here they can view data of their choice and customize map products for printing themselves. Access to the GIS data, summary tables and methods report is also available through this website.

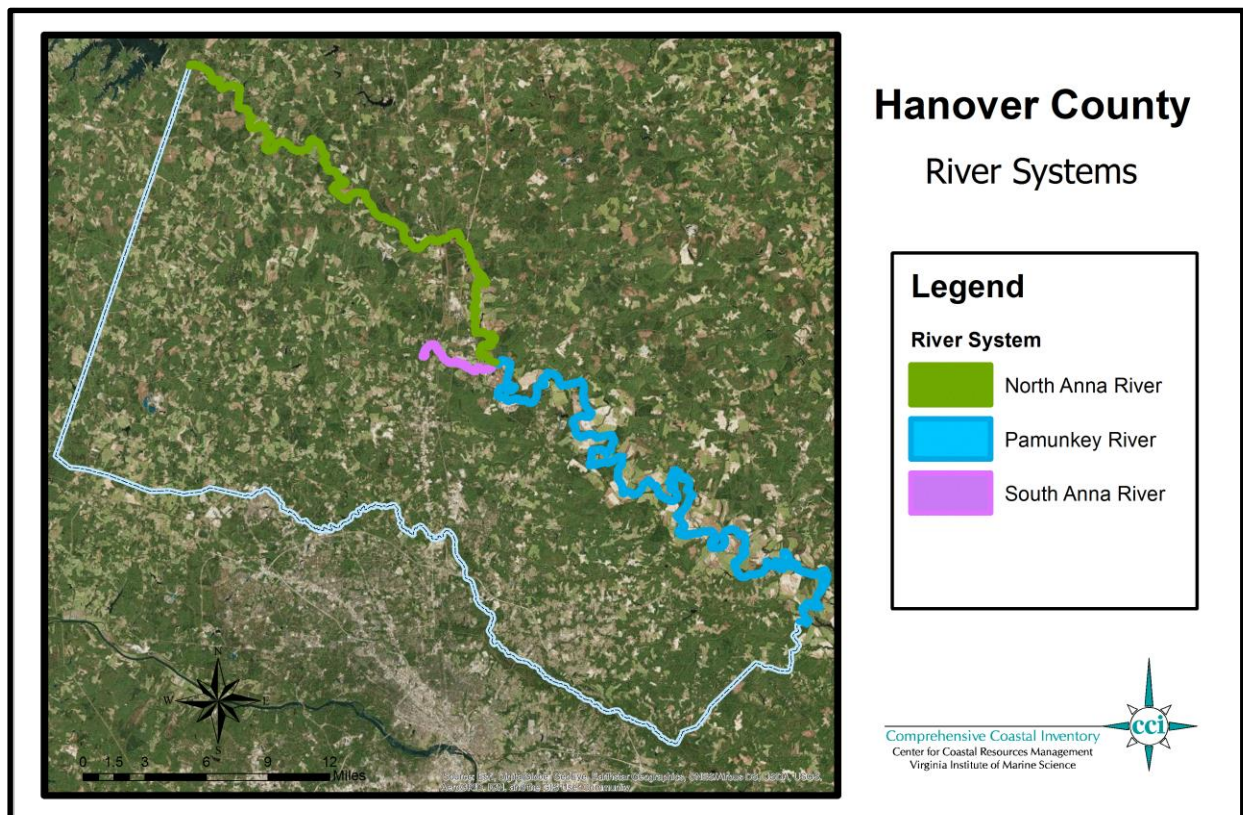
Figure 2. River Systems in Hanover County

Summary tables (Tables 4-7) quantify conditions observed on the basis of river systems (Figure 2). Refer to Figure 2 for the location of these river systems. Note, river systems do not correspond to watershed boundaries. They were developed for convenience in reporting data.

The top toolbar also includes tabs to access some important status information for the locality. By clicking on the “River System Pie Charts” button, users can obtain a statistical summary distribution of the riparian land use and amount of hardened shoreline for a specific water body selected from the drop down menu in the upper left (Figure 7). More detailed results in table format can be found by clicking the Hanover County Summary PDF button also in the window. The summary statistics are reported by river systems (Figure 2).

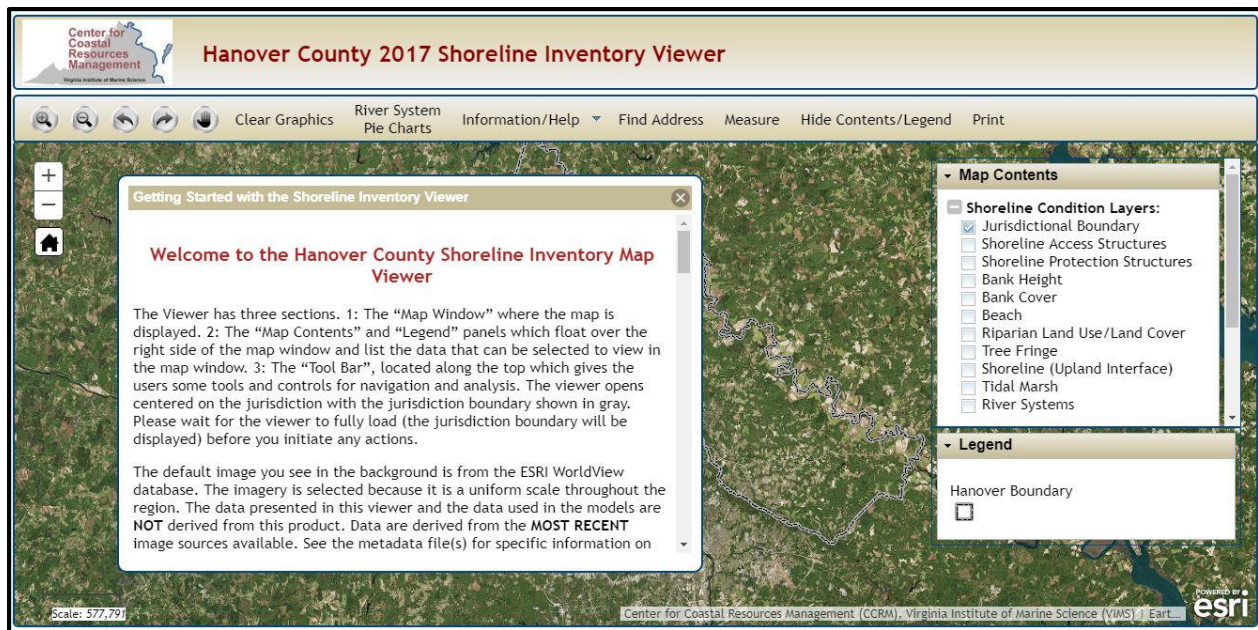
Figure 3. Opening page for the Hanover County Shoreline Inventory Viewer

The Viewer has two panels: “Map Window”, where the map is displayed and “Map Contents and Legend”, where data that can be selected and viewed in the map window are listed. A tool bar is located along the top of the “Map Window” which gives users some controls for navigation and analysis (Figure 3.).

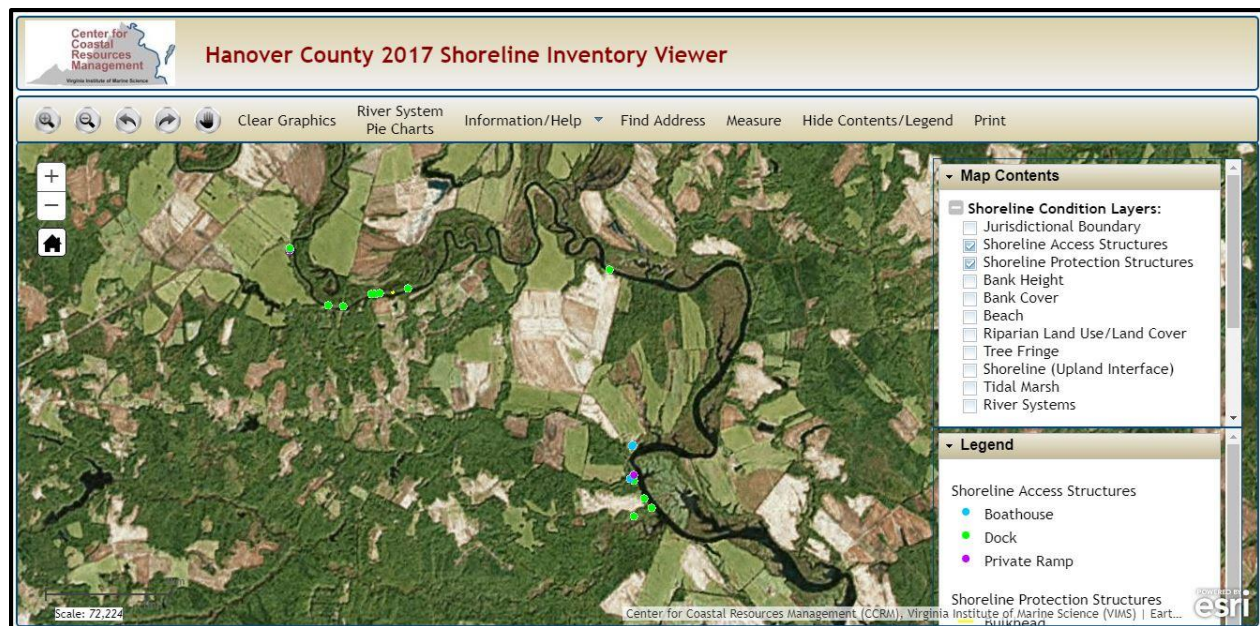
Figure 4. Map Viewer illustrates Shoreline Access and Protection Structures for a section of Hanover County.

In Figure 4 Shoreline Access Structures, and Shoreline Protection structures are selected. Shoreline Access structures are point features that includes piers and boat ramps. The actual footprint of these structures is not measured; only their location. Shoreline Protection Structures are line features and are mapped and illustrated in the viewer to show where they occur along the shoreline. Figure 5 illustrates riparian land use in the riparian zone for the same section of the County.

From the “Map Contents” the user may check various attribute layers on or off. The user must use the scroll bar on the far right to see the complete list of layers available. When layers are turned on, the corresponding legend appears in the “Legend” panel, and the data are displayed in the “Map Window” (Figure 4).

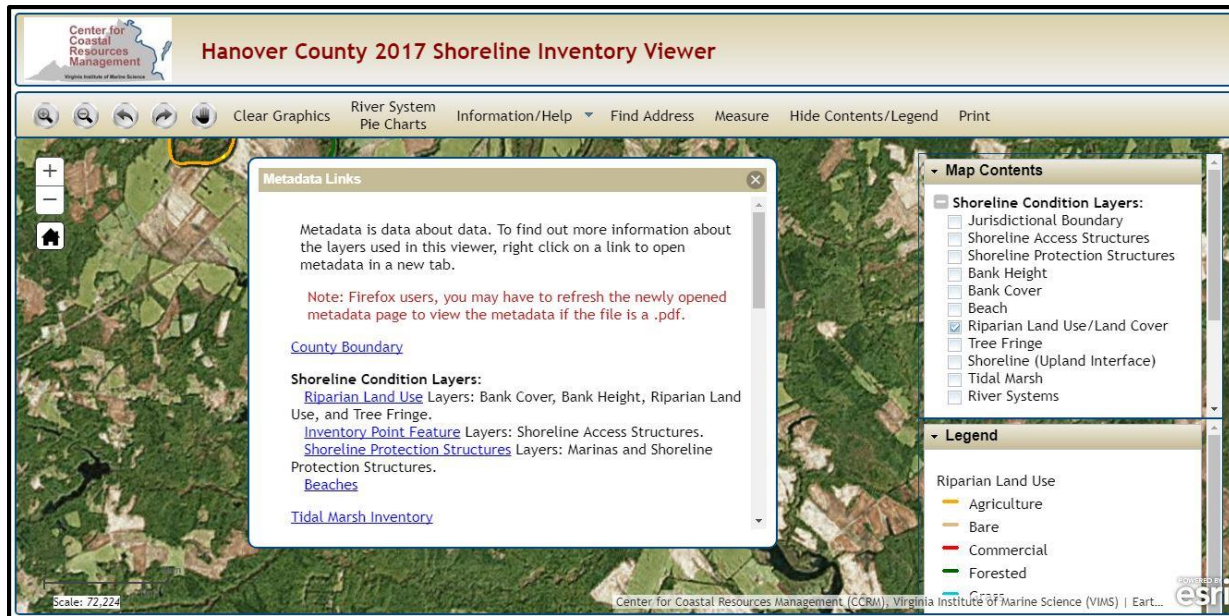
Figure 6. Link to Metadata records has been selected from the top Information tab in the toolbar.

The user can use the zoom and pan tools from the top toolbar or the slide bar on the left side of the map window to change their map extent. If the map resolution is exceeded the window will become illegible. Detailed information can be obtained about the data by selecting the “Information/Help” tab at the top of the map viewer. From here the inventory glossary and metadata records can be easily accessed. In Figure 6 the selection for metadata has been made and 5 possible records can be retrieved.

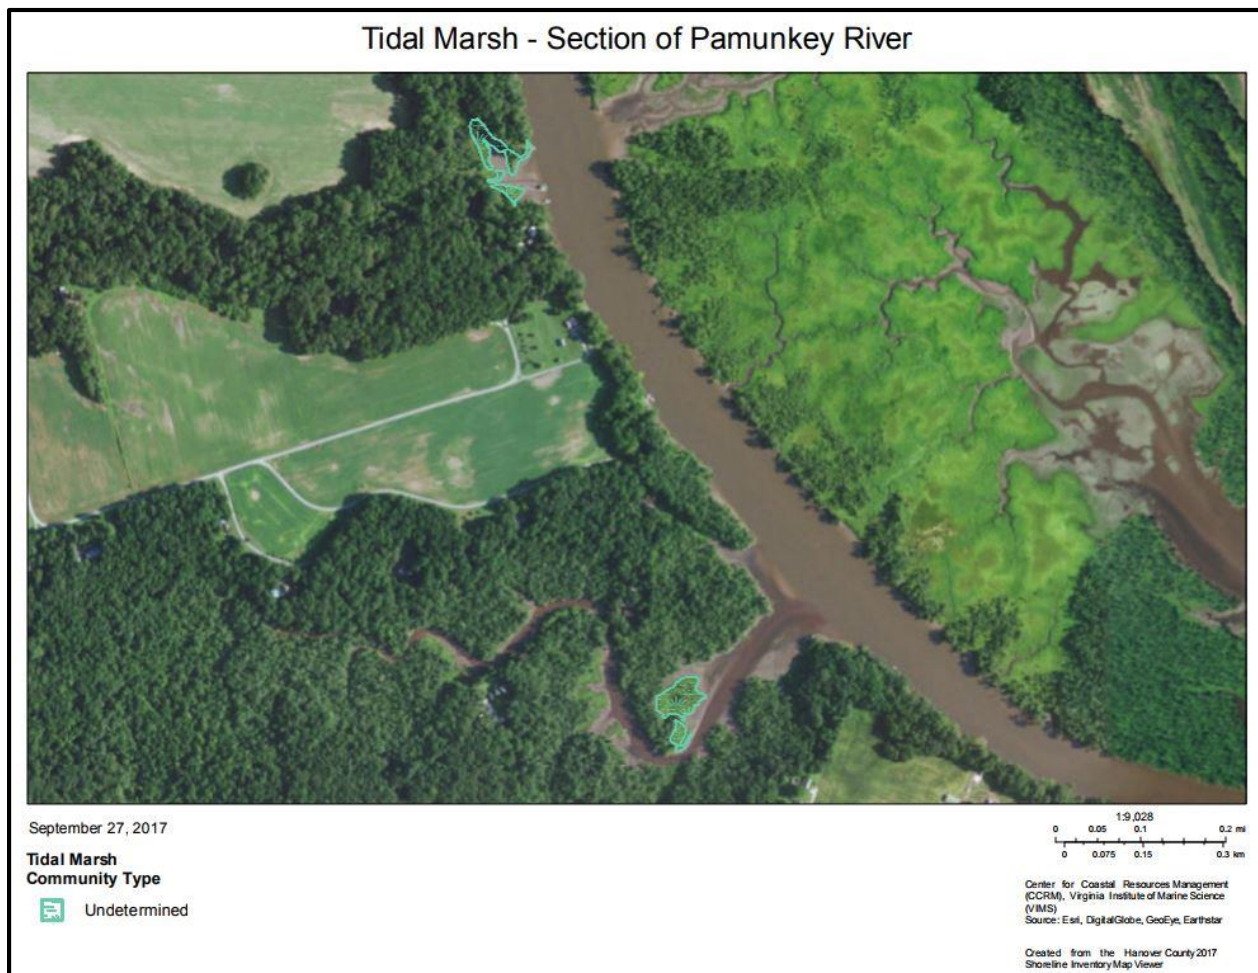
Figure 8. Customized print window for a section of Pamunkey River.

Finally, users have the option to personalize their own maps (i.e. map extent, data displayed, map title, etc.) and save them as a pdf file by clicking “Select Print Layout” button. The page can be set up for printing to 8.5 x 11 portrait or landscape style. Figure 8 is an example of a customized map generated for a section of Pamunkey River. Here the tidal marsh communities are displayed, and the community type is reported in the legend beside the illustration.
